## **Effect of Geological Characteristics on Landslides and Floods in Karangtengah**

### **Abstract**

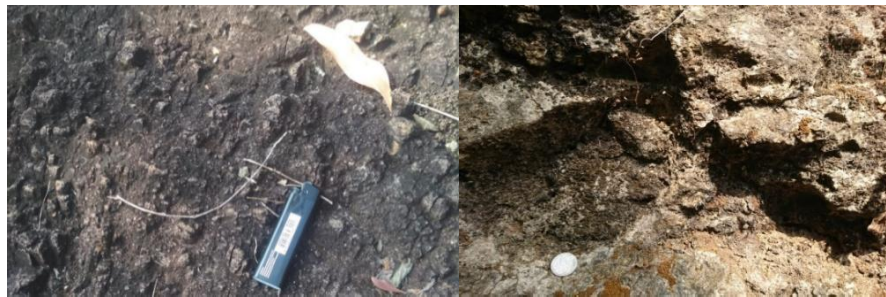
Figure 1. (Left) Lithology in the form of breccia of the ngalanggran formation on the slopes of the bag, (right) limestone of the Wonosari formation on the downstream housing

Karangtengah village is dominated by young Merapi deposits and also alluvial deposits, on the slopes there is a ngelanggran formation and From the results of field observations carried out on March 2021, it was found that rock outcrops located at the top of the hill in the Karangtengah village area are breccias. volcanic rocks and rocks included in the Ngelanggran Formation, western Bada in a flatter area

there are rock outcrops in the form of limestone that enter the Wonosari Formation, the body of the slopes in the middle coral village is dominated by soil and weathered breccias, on the upper slopes are still found in the form of rocks the breccias are still fresh, while at the crown to the foot of the avalanche it is in the form of weathered breccias and quite thick soil, Conditions in the form of thick soil also affect the water absorption capacity around the slopes, which causes rainwater to not seep maximally so that the overflow of water from the slopes to the watershed, in this case Kaliceleng, is quite large. From the results of field observations conducted on July 23, 2021 obtained outcrop at coordinates x: 433281, y: 9122039 on the upper slopes, the outcrop obtained in the form of breccia with a light brown to dark color, large grains of crystal - krakal, corner, badly separated, open pack, the composition of fragments in the form of andesite-basalt and a minute of silica, Massiv Limestone outcrop at coordinates x: 432411, y: 9122783 on the lower slopes, the outcrop obtained in the form of limestone white to dark color, non-clastic sediment, dengan struktur masiv, komposisi mineral CaCo3

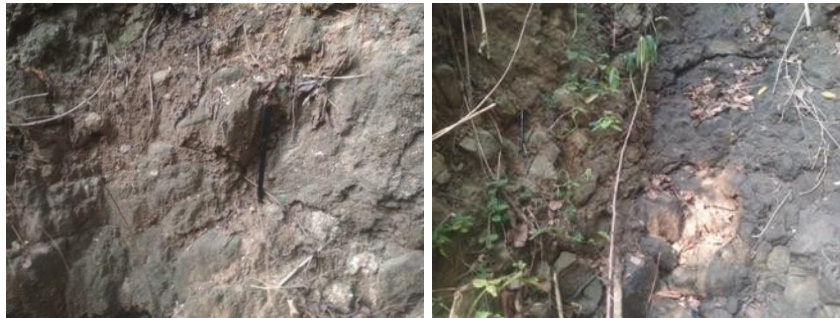
**Figure 3. Joints formed in the landslide area**

One of the factors that influence the occurrence of landslides is influenced by weak zones, including structural control, in the Karangtengah area the control structure that dominates in the form of joints in sandstone and breccias at the top and bottom of the slopes, this weak zone can cause further

damage. unstable slope because it can become a place that is saturated with water, The joint located in Karangtengah Village, besides being able to pass water and saturate it is thought to be associated with faults close to the research location, namely Opak Fault, general direction join in Karangtengah village N013°E/51° and N249°E/53°

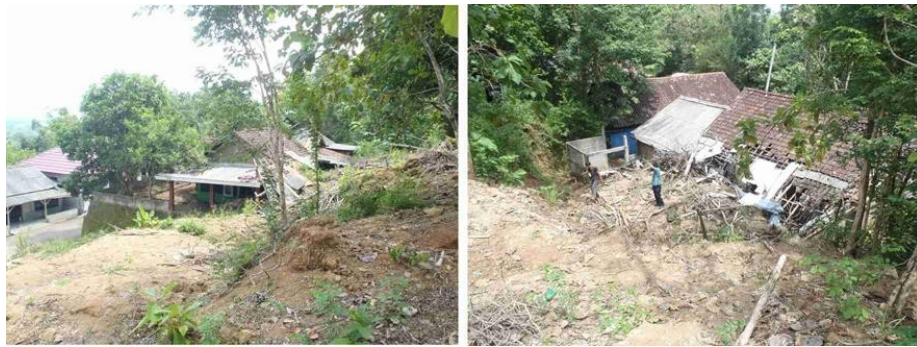
Figure 3. Karangtengah avalanche which resulted in the destruction of houses

The type of avalanche is in the form of debris flow. Debris flow tends to follow the direction of the slope. The flow of debris is a rapid mass movement consisting of soil, rock and often contains organic content mixed with water which then flows down the slope. The speed of this density movement can be very fast (56 km/hour), depending on the slope angle. The main trigger of this type of mass movement is the large volume of surface water flowing, the amount of water flowing in the aquifer, which then erodes and triggers the movement of material down the slope. The landslide event in Karangtengah Village was actually more influenced by the weather anomaly that occurred at the end of 2017.
