Analysis of Runways Surface Conditions Using Pavement Condition Index Method (Case Study: I Gusti Ngurah Rai International Airports)

I Putu Dika Irvayana¹, Yackob Astor¹, Atmy Verani Rouly Sihombing¹, Asep Sundara¹

¹Civil Engineering, Politeknik Negeri Bandung, Indonesia.

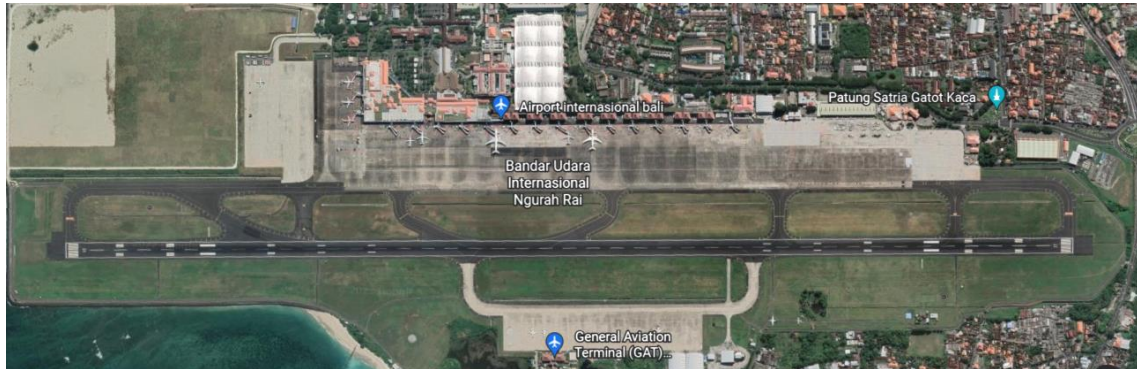
Figure 1. Layout I Gusti Ngurah Rai International Airports

Based on the results of visual inspections carried out on August 8, 2022, to August 18, 2022, on the runway of the I Gusti Ngurah Rai International Airport, technically carrying out visual inspections, inspections are carried out on three segments every day to obtain the type of distress, distress levels, severity and the percentage density of each runway segment that is visually inspected. The table below shows the recapitulation of distress type, distress level, severity, and density percentage of every segment divided into 30 segments.

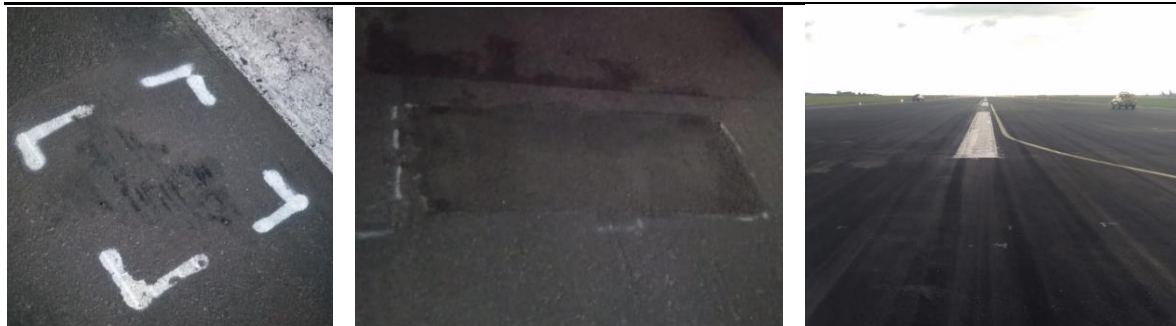
Based on the visual inspection results, several types of distress are inspected on the I Gusti Ngurah Rai International Airport runway surface, such as bleeding, jet-blast erosion, patching, ravelling/ weathering, alligator crack, joint reflection, bleeding, polished aggregate, and block cracking. However, generally, the runway's pavement at I Gusti Ngurah Rai International Airport is disintegrated, and loss of skid resistance with the most dominant type of distress is patching, jet-blast erosion, and bleeding.

Figure 2. Dominant distress type in I Gusti Ngurah Rai International Airports runway surfaces

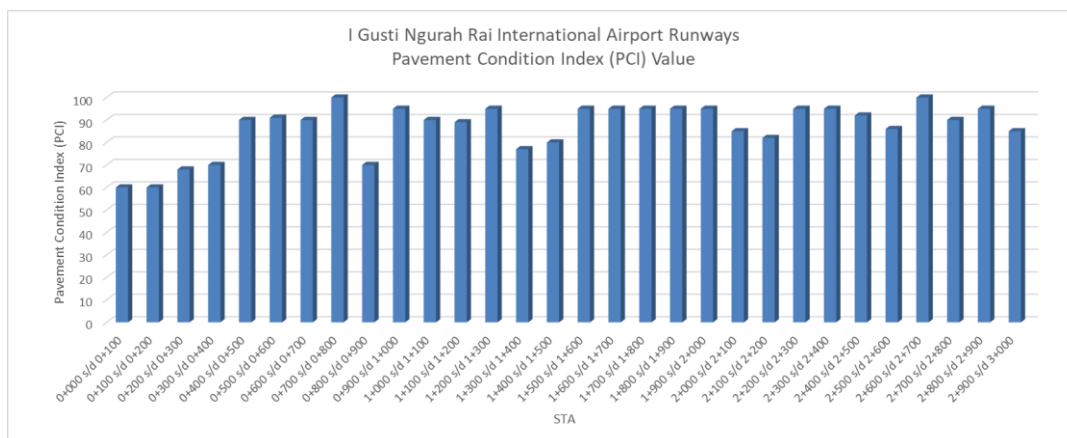
The analysis results using the pavement condition index (PCI) method show that runways I Gusti Ngurah Rai International Airport at STA 0+000 – STA 0+400 and STA 0+800 – STA 0+900 have PCI values between 56-70 it is in fair condition so that the runways at that area need treatment as like resurfacing with overlay addition and inlay-scrape and fill to increasing the PCI rating to reach the good condition. Runways I Gusti Ngurah Rai International Airport at STA 1+300 – STA 1+500, STA 2+000 – STA 2+200, and STA 2+900 – STA 3+000 have PCI value of 71-86; it is in satisfactory condition so that the runways at that areas need treatment as like a minor rehabilitation by doing patching at distress area to increase the PCI rating to reach the good condition. Runways I Gusti Ngurah Rai International Airport at STA 0+400 – STA 0+800, STA 0+900 – STA 1+300, STA 1+500 – STA 2+000, and STA 2+200 – STA 2+900 is having PCI value at 86-100 is in good condition that does not need any action, and the results show that I Gusti Ngurah Rai International Airport runways average PCI value is 86,83 overall the runway PCI value is in good condition that does not need any action.

Figure 3. I Gusti Ngurah Rai International Airports each segments PCI value
